# Mirage B-5030-G Repair

Author: Jim Bacher, WB8VSU

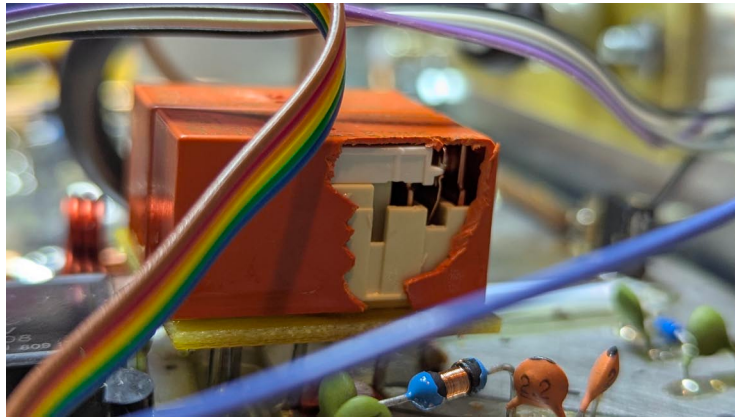
While I was considering that, it occurred to me it's just dirty relay contacts and there is this product called contact cleaner. So taking an Exacto Knife, I carefully cut off part of the relay's case. See Picture # 1 of what it looked like cut open. I was then able to spray contact cleaner in it and cycled it a few times, and it was back to normal contact resistance. Thinking I had it fixed, I tested it and found the SWR was even worse.

In this picture you can see the cut open relay along with the stilt the board is on. You can also see the inductor I smoked.

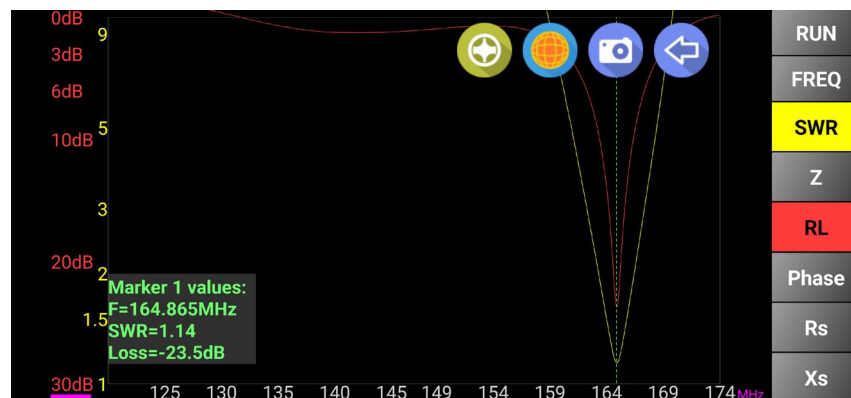
First scan with VNA Picture # 2

I talked to Tom Holmes, N8ZM and he suggested I use a VNA to check the Amp's input (with it keyed of course). I got out one of my VNAs and checked the input. Doing so showed it had input impedance issues as it was resonant at the wrong frequency. See Picture # 2. I would never have thought of using a VNA, so thanks to Tom for suggesting that. I discovered that one of the input capacitors was bad. It was a Mica Capacitor 750pF 300V 5%.

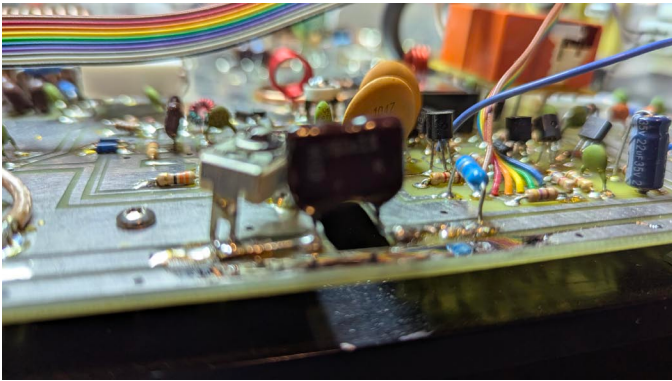
Picture # 4

The Amp had a number of same value caps. Some were 300 VDC and some were 500 VDC, I thought I would be smart and buy a couple extras just in case and go with the 500 VDC version. That turned out to be a mistake as well. Once the 500 Volt capacitors arrived, I replaced the Mica Capacitor. The VNA said it was better, but still not great. See Picture # 6. Tom suggested the size of the capacitor was having an impact. So I ordered the smaller 300 VDC capacitors along with 0.47 uH inductors. Replacing the capacitor with the smaller 300 VDC version improved things, see Picture # 7, so Tom was correct, but it still was not what it should have been. In general I always try to only change one

In picture # 4 above on the left you can see the first 500 VDC capacitor that I used and how it is touching the trimmer capacitor. In picture # 5 above on the right, you can see the 300 VDC capacitor is smaller and does not touch the trimmer capacitor.

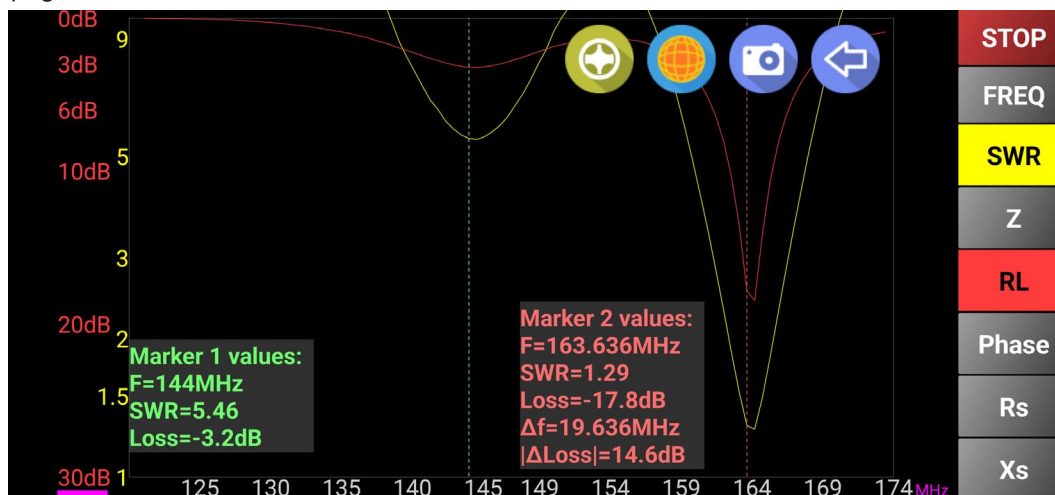
Picture # 6

With 500 VDC Capacitor

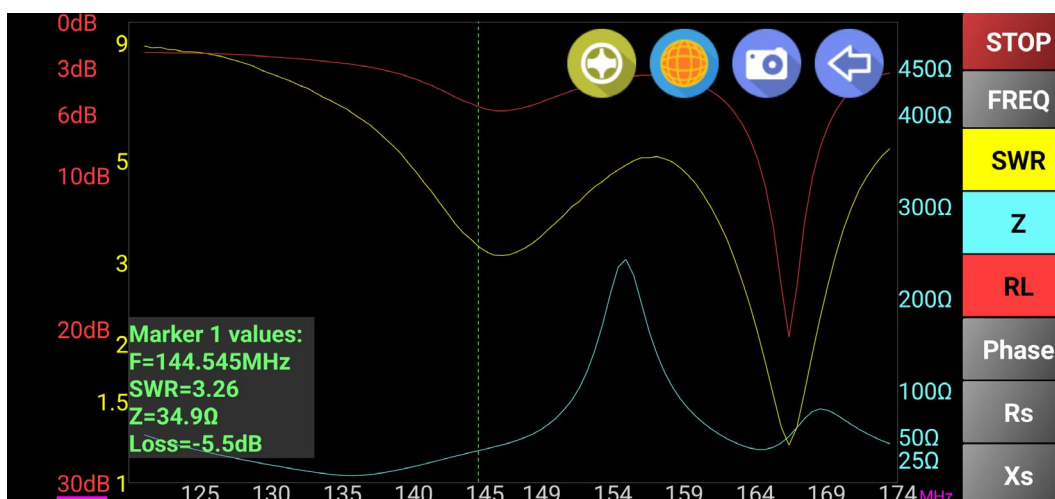
Picture # 7

After Changing Capacitor to a 300 VDC Capacitor

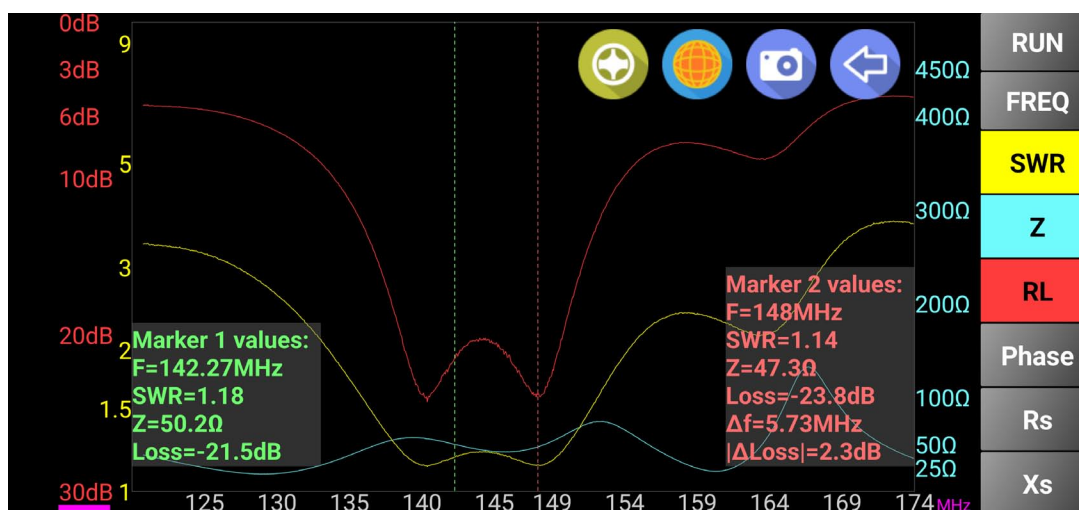
Picture # 8

I then replaced the inductor and the VNA showed I was on the right track. I then used the VNA to adjust the variable capacitor. Now the VNA says it looks good, see Picture # 8. VNA says it has a 1.2 SWR in the 144.200 MHz range and the ICOM IC-9700 shows about the same amount now that its back in place. In the past it's SWR on the ICOM 9700 was always about 1.8 and as it was rated at 1.8 or less I had figured that was normal. The other interesting thing is I had to reduce the ICOM 9700's power out to maintain the previous power out of the amp. I run the amp at 225 watts instead of it's rated 300 Watts, to stay below the high power class for contest submittals.

After Replacing L1 the Inductor that was smoked

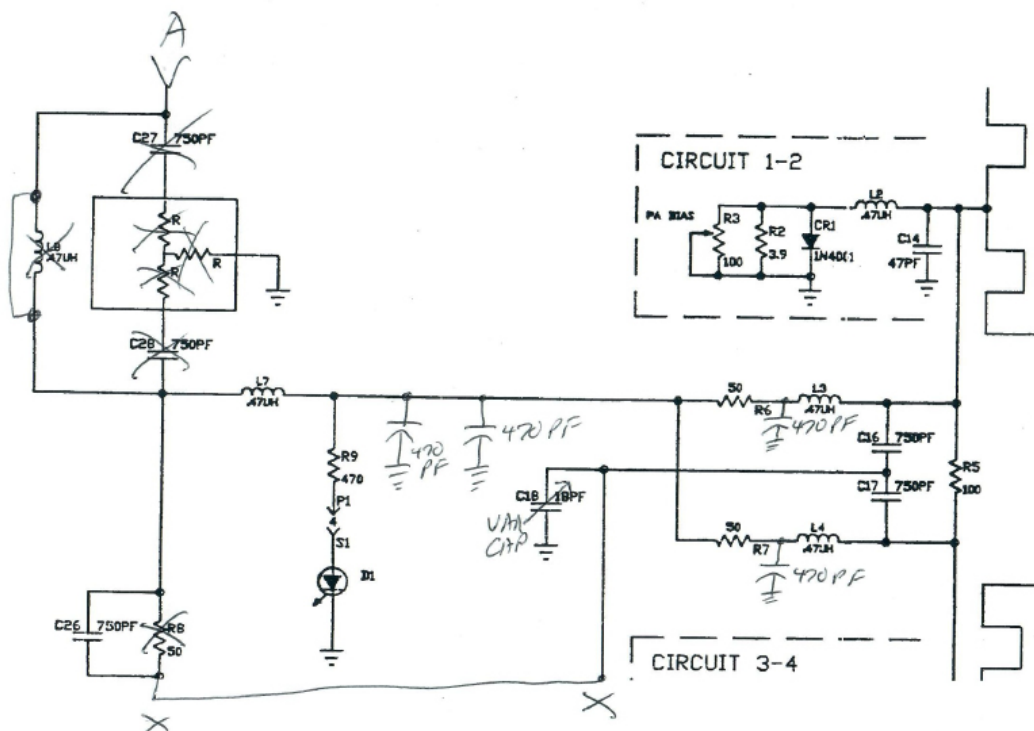
In Picture # 9 which shows the B-3030's schematic for it's input to the driver section. I have marked up it up for the differences between the B-5030-G and the B-3030. Unfortunately for me, my issues appeared to be in the area that was different.

This image has the changes between the B-3030 and the B-5030.

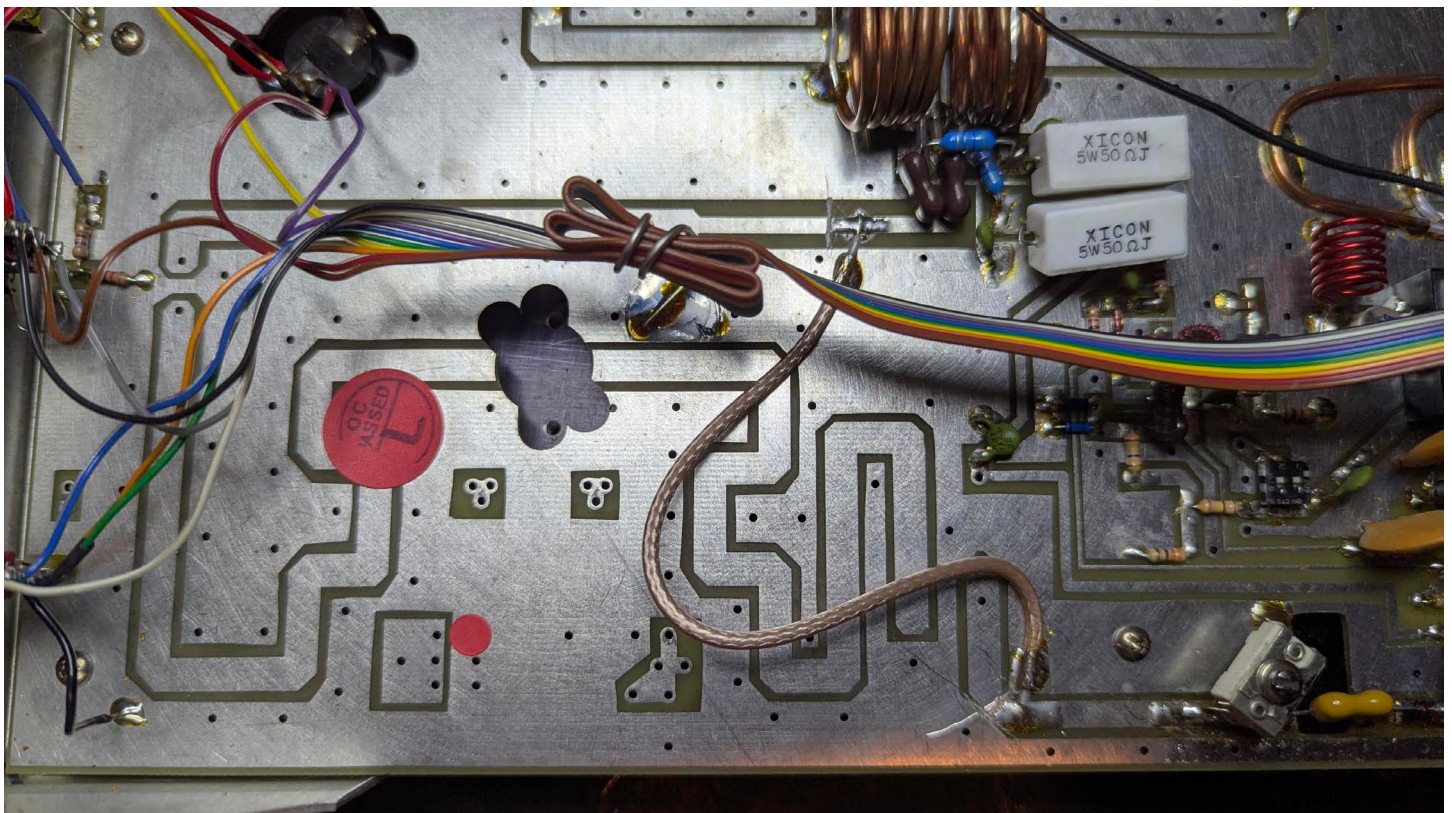
I did not have any schematics for it, so I started searching for one on the Internet, but could not find one. I did find one for a Mirage B-3030 on the Repeater Builder's website. The B-3030 had slightly different input ratings, however its output ratings were the same as the B-5030. I suspected it might be similar to my amp, so I downloaded the schematic hoping I might be able to use it. Looking at the B-3030's schematic, it shows it has an input driver section. I opened up the amp and found its circuit board had a pre-driver area bypassed with a piece of coax. I suspect the B-5030 and the B-3030 use the same circuit board and most all the same components, except for the pre-driver section. See Picture # 10 showing the coax bypass of the pre-driver section of the PC Board.

This picture shows the coax bypass of the driver section of the board.
